Stefan Wilke, DESY MHF-e

Unexpected trouble with the PETRA veteran cavities

16th ESLS rf meeting

ALBA, Barcelona, 2012-10-09/10

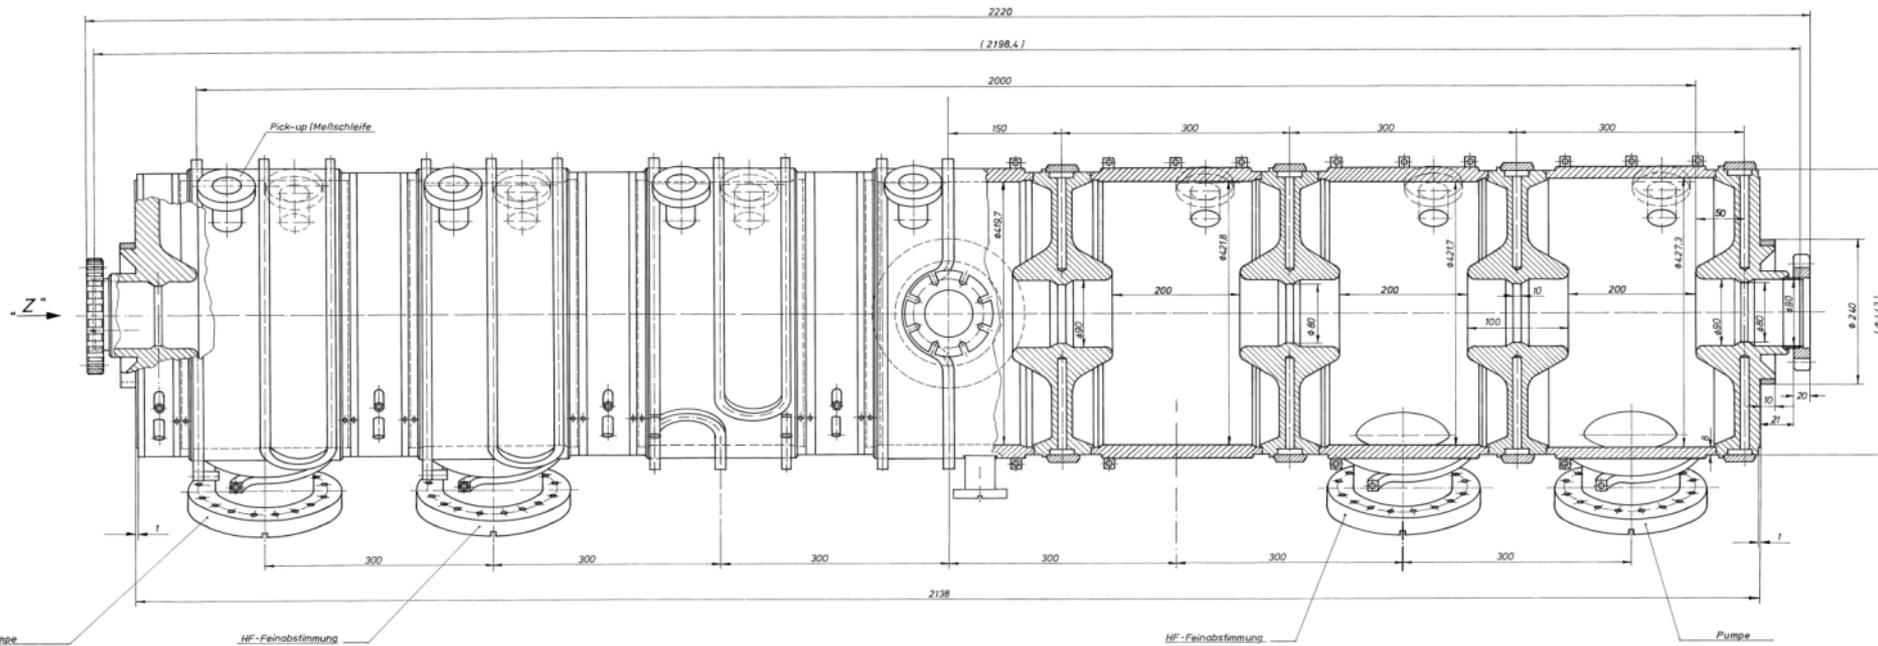
7 cell cavity, 500 MHz.

For PETRA III we re-installed 12 of the old 16 installed 7-cell cavities.

Shunt impedance: ca. 23 MOhm

Band width: ca. 54 kHz

Coupler transmission power: ca. 125 kW

Couplers originally designed for 60 kW,
but already operated at DORIS 2 up to 120 kW.

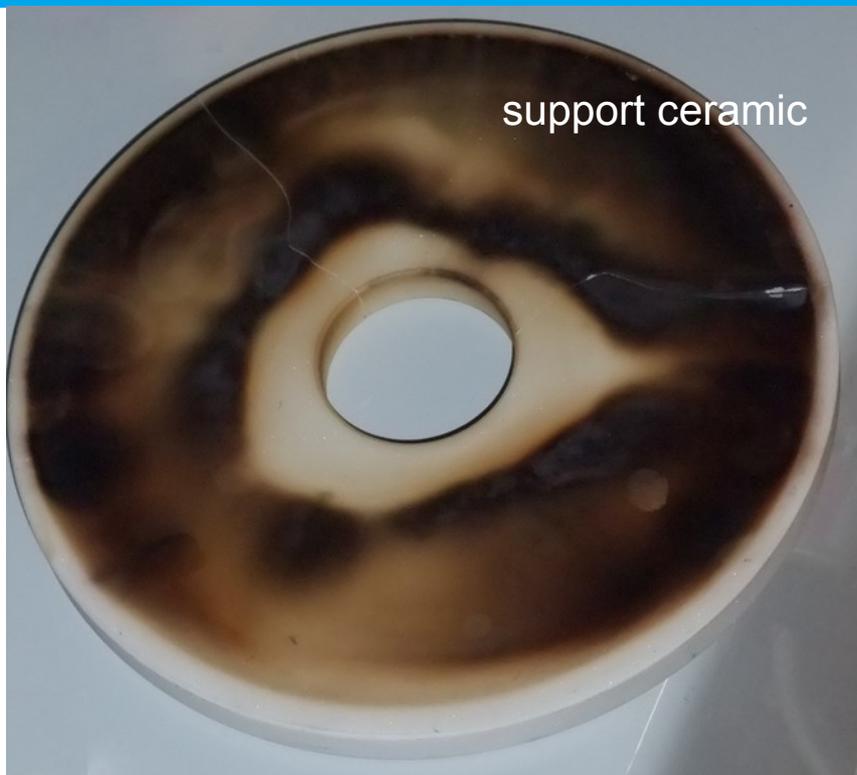
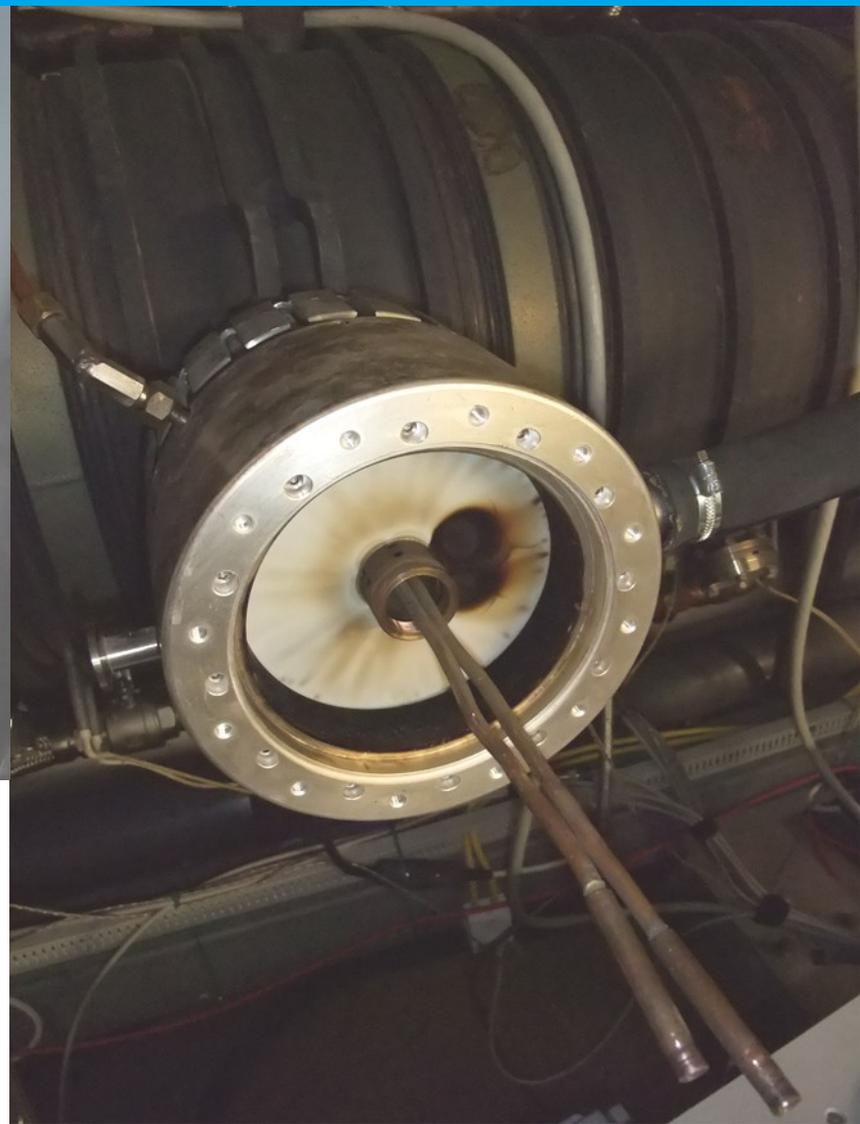
This happens on 2010-11-10 at SL_Cy4:
An almost broken ceramic.
Only noticed by a very high difference
temperature of the cooling air of the
coupler.

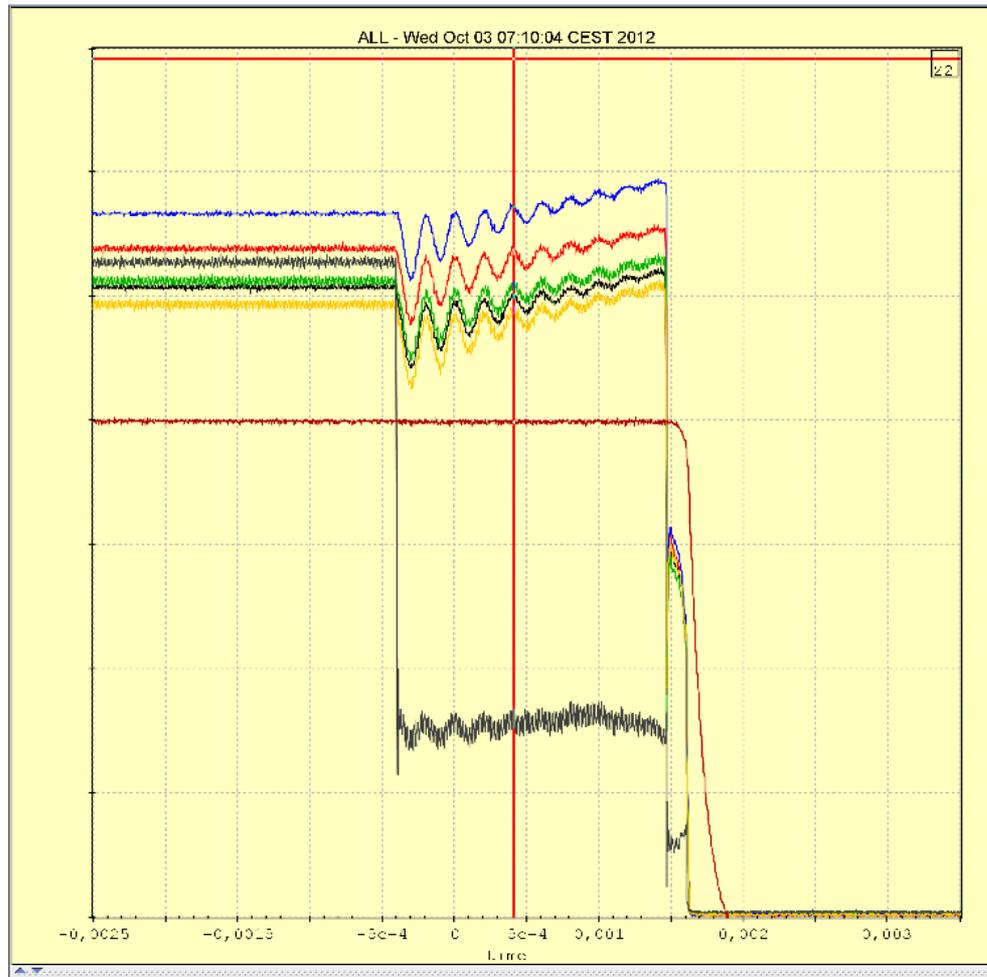
Watched at different cavities. Here SL_Cy6

Sudden voltage breakdown in one cavity.

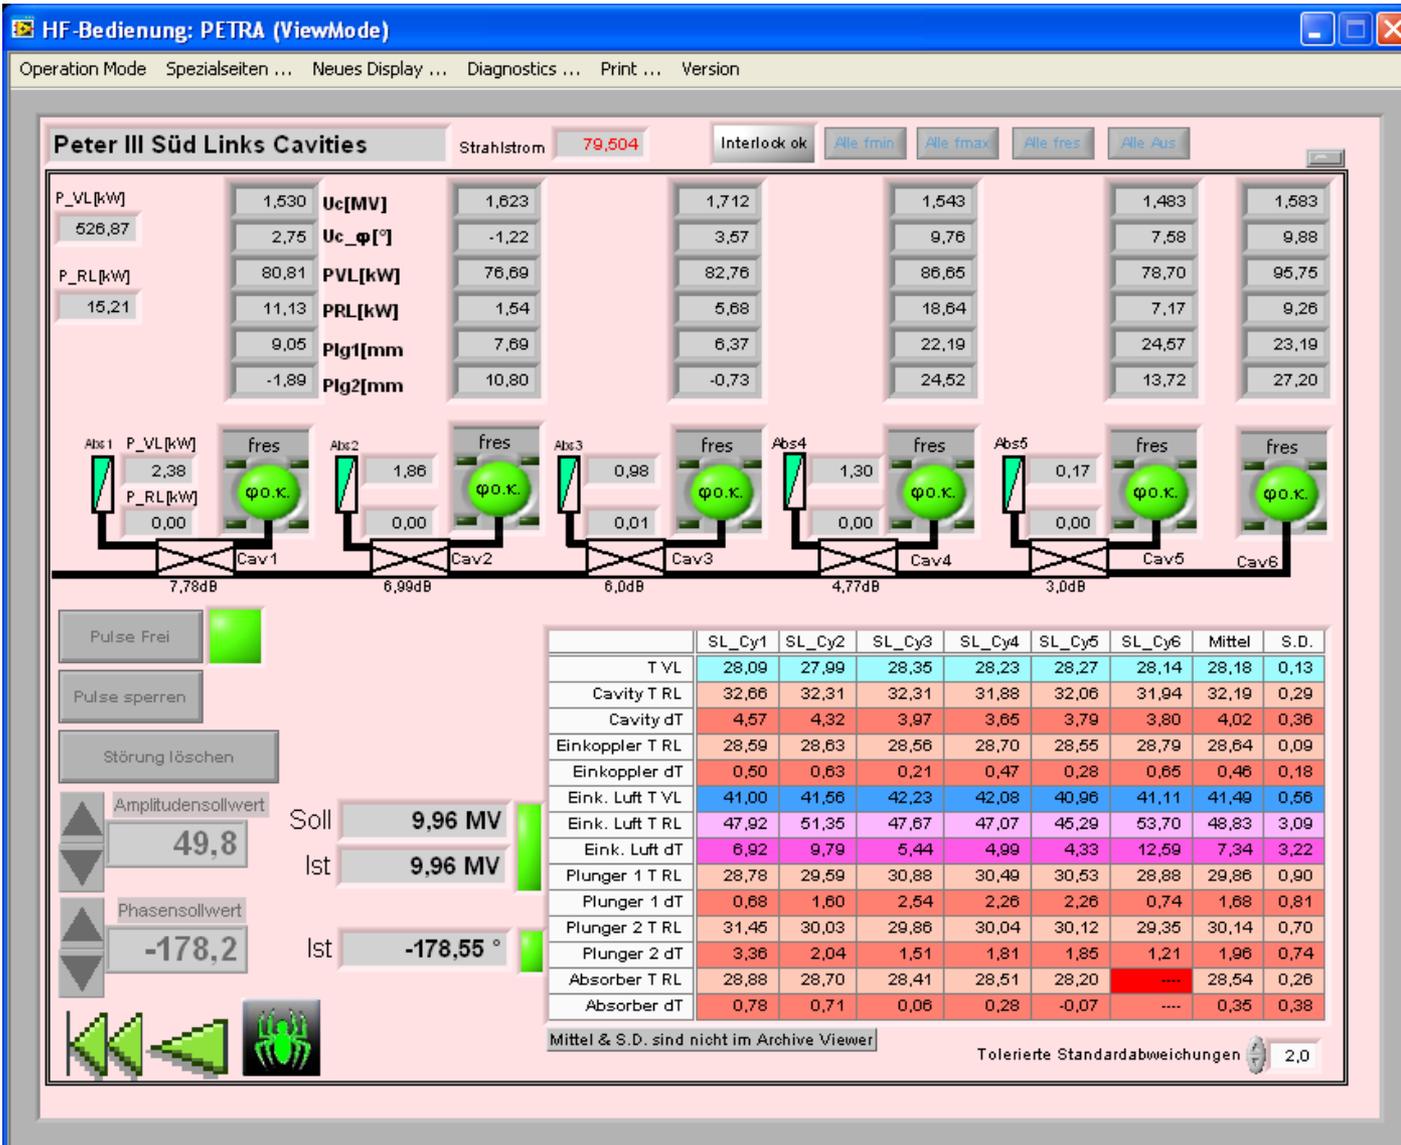
Detection of sparks by looking on fast change of power in absorbers. This fast interlock is done by hardware. Additionally there are light sensors.

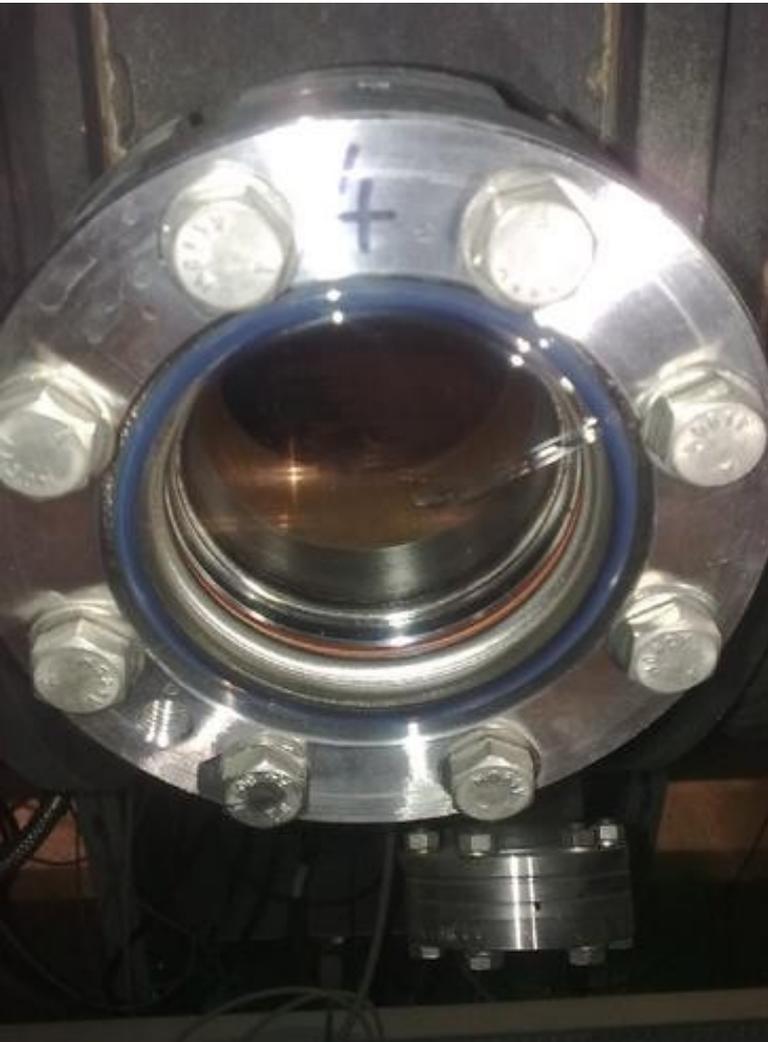
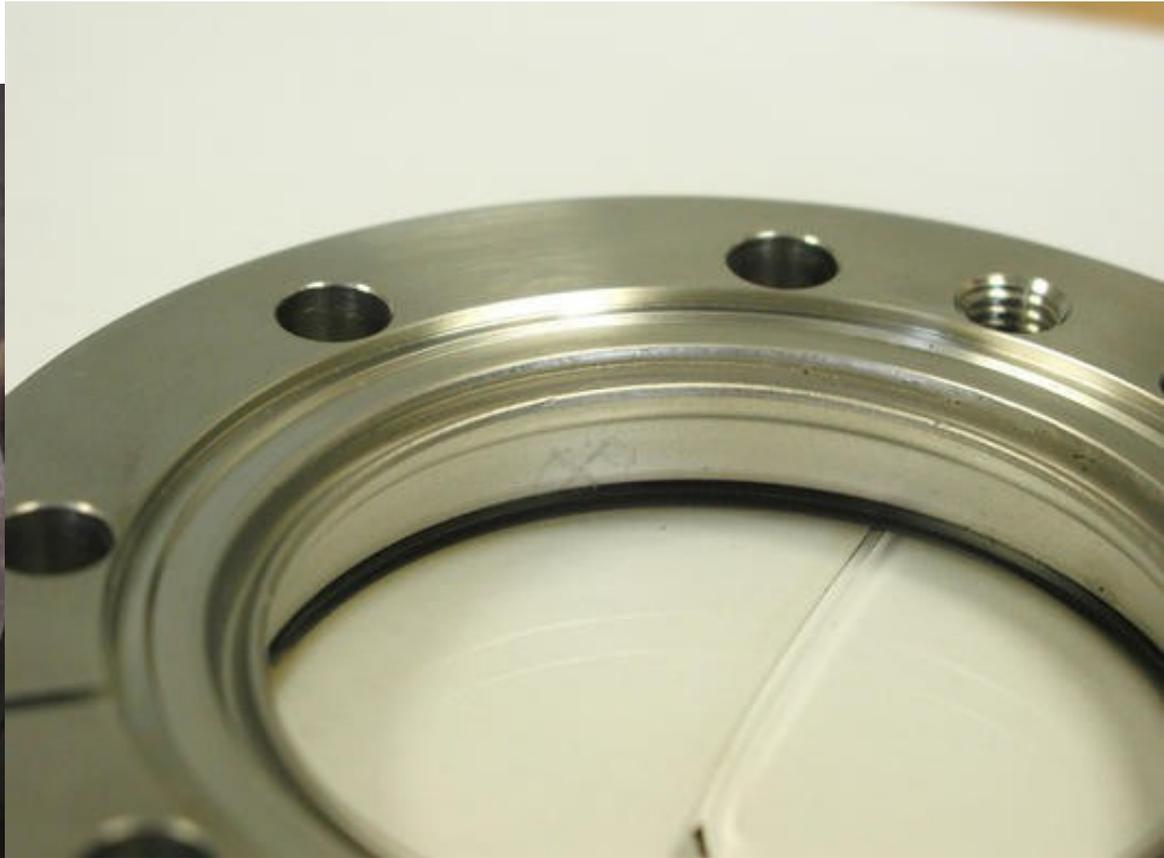
> 2011-05-11 at PE_SR_Cy3

Broken quartz glass window.

This was never seen before.
Reason unknown.

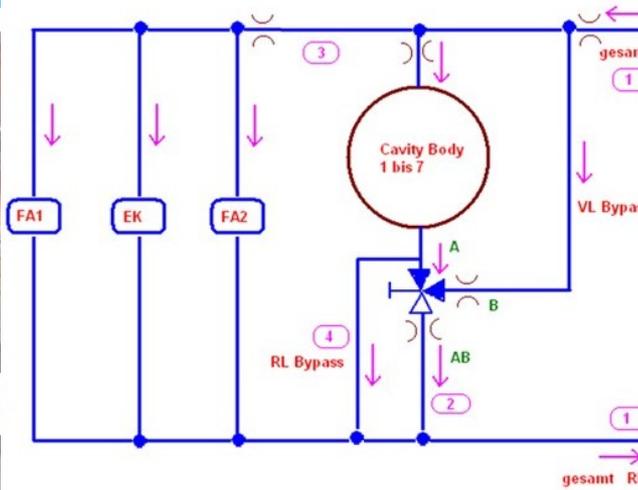
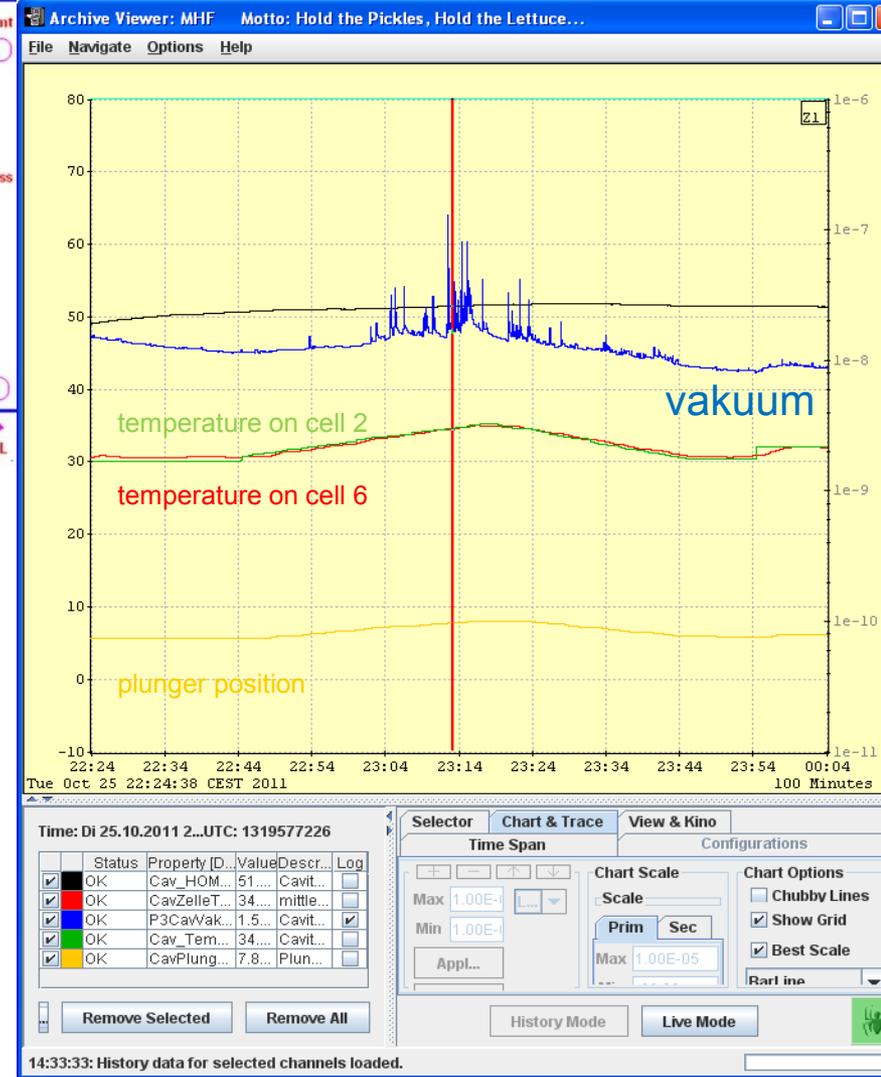
Individually regulation of cavity temperature.

variation: only max. ca. 3 degree

At some cavities very strong relation: temp. - vac.

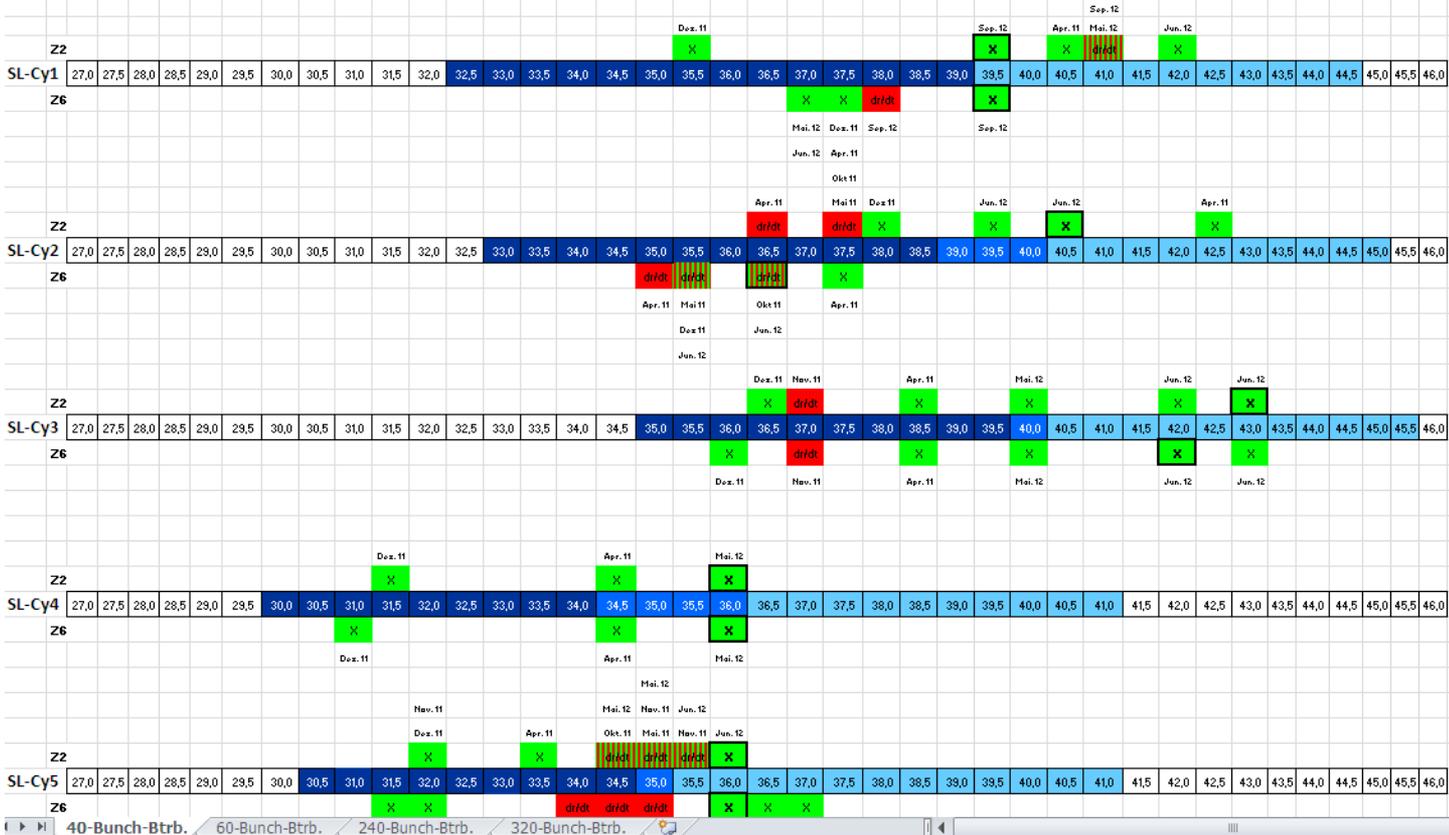
Stand: 03.10.2012

Temperature maps.

Geeignete und zu vermeidende Cavity-Temperaturbereiche

The "best" temperature for each cavities is found empirically. It depends on the number of bunches.

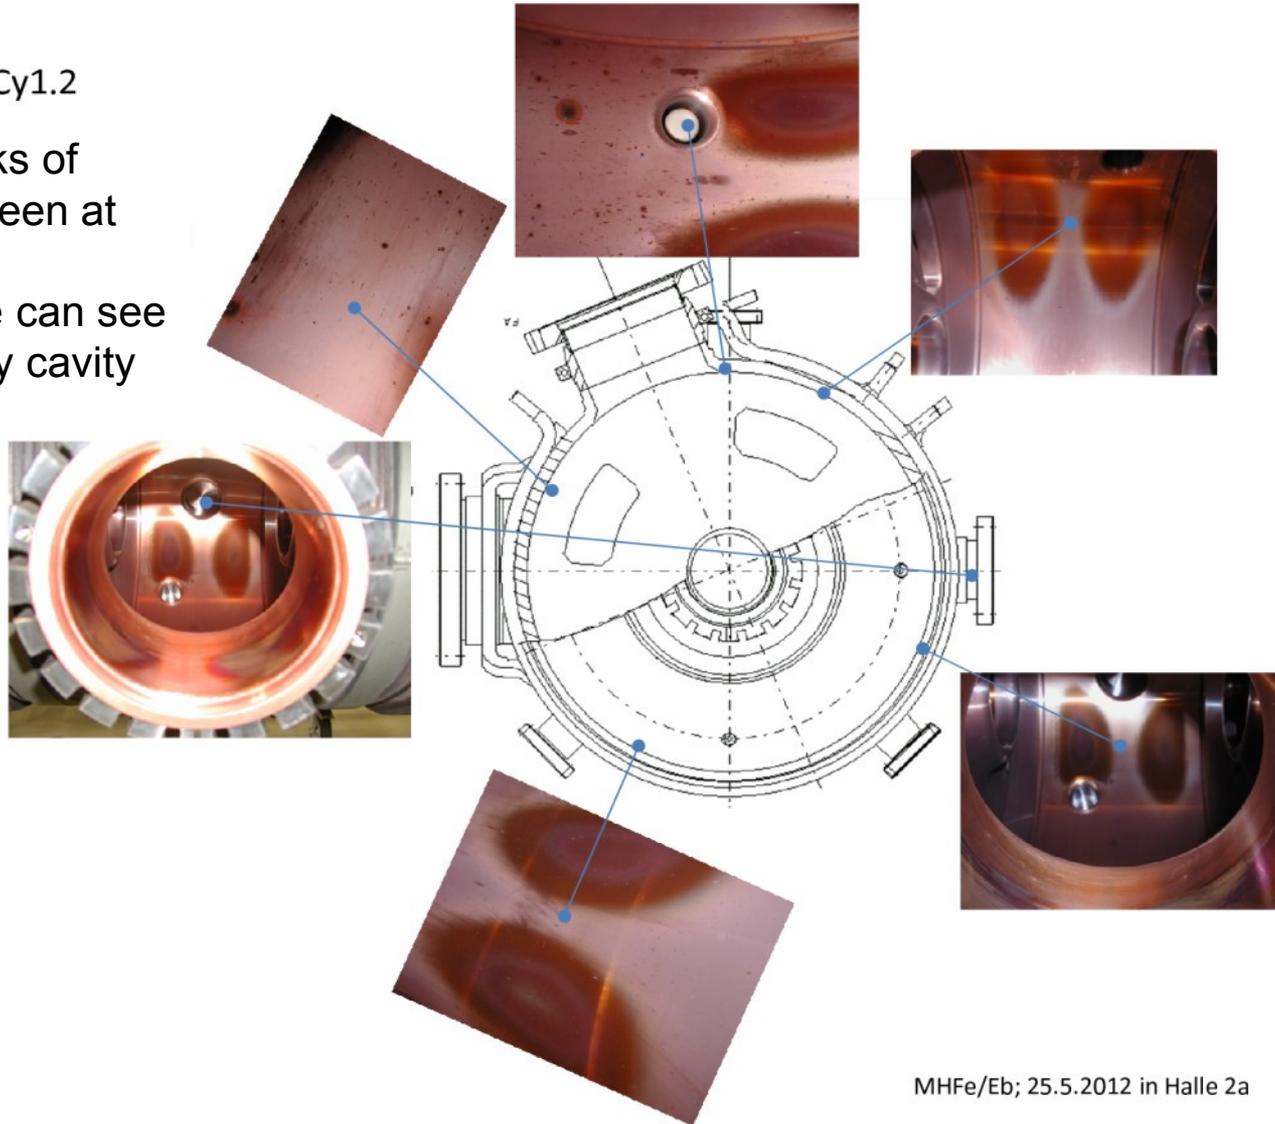
Cav #43

Pictures from inside a cavity taken by an endoscope.

similar marks of
HOMs (?) seen at
SR_Cy3.

Perhaps we can see
that at every cavity

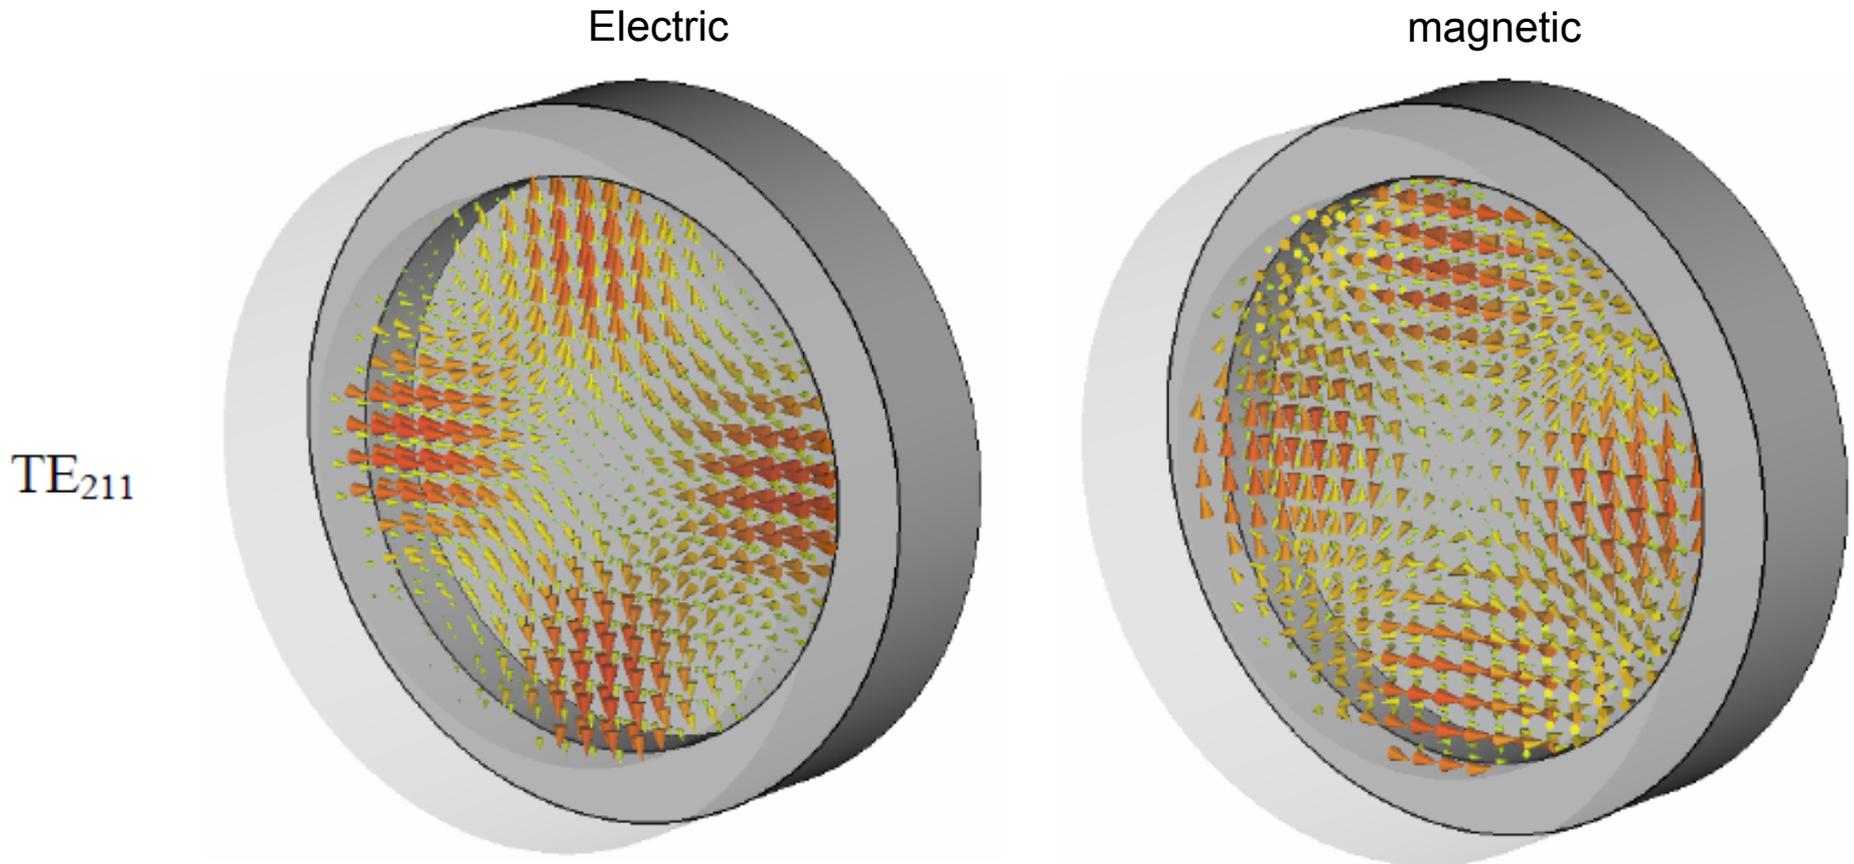
HOMs? painting mystery.

Is this the responsible mode?
We need it two times longitudinally!
 $f = 1,42 \text{ GHz}$?

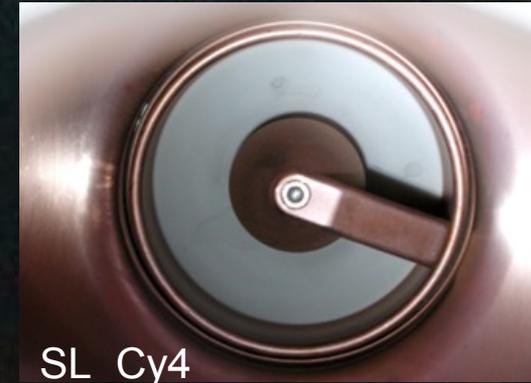
SL_Cy4

Grey parts on coupler ceramic.

We see this and similar pattern on some other cavities. Also observed at DORIS.

The cavities with that grey ceramics did NOT trip more often!

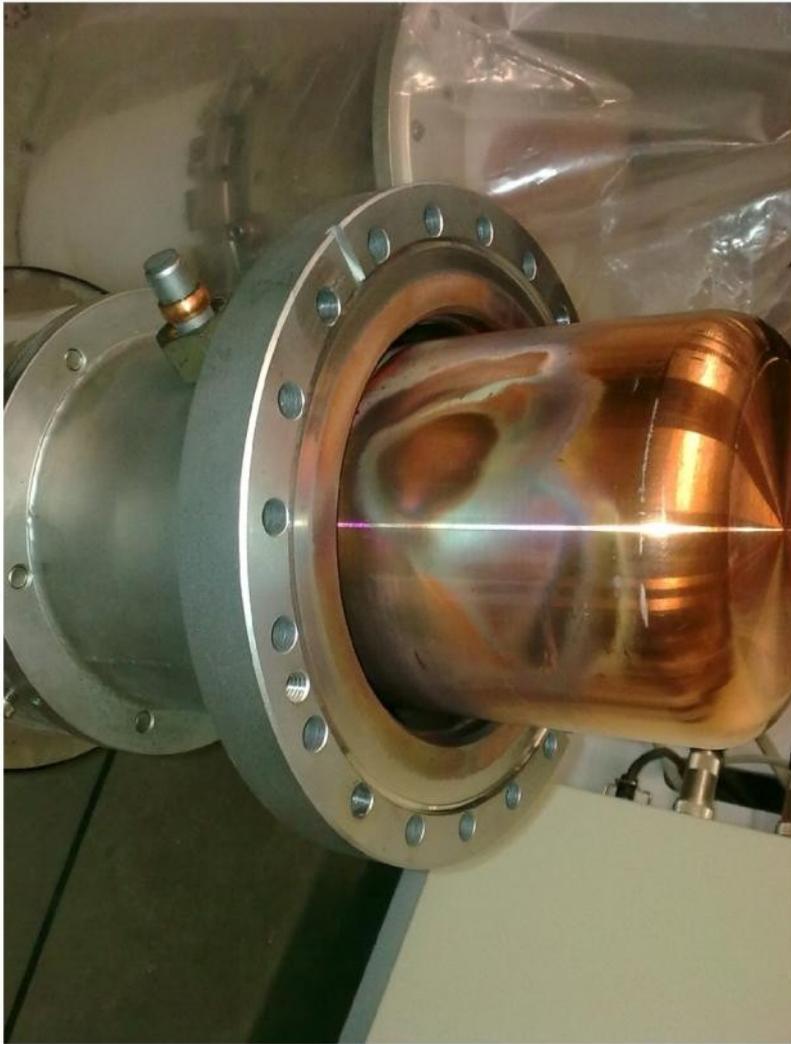
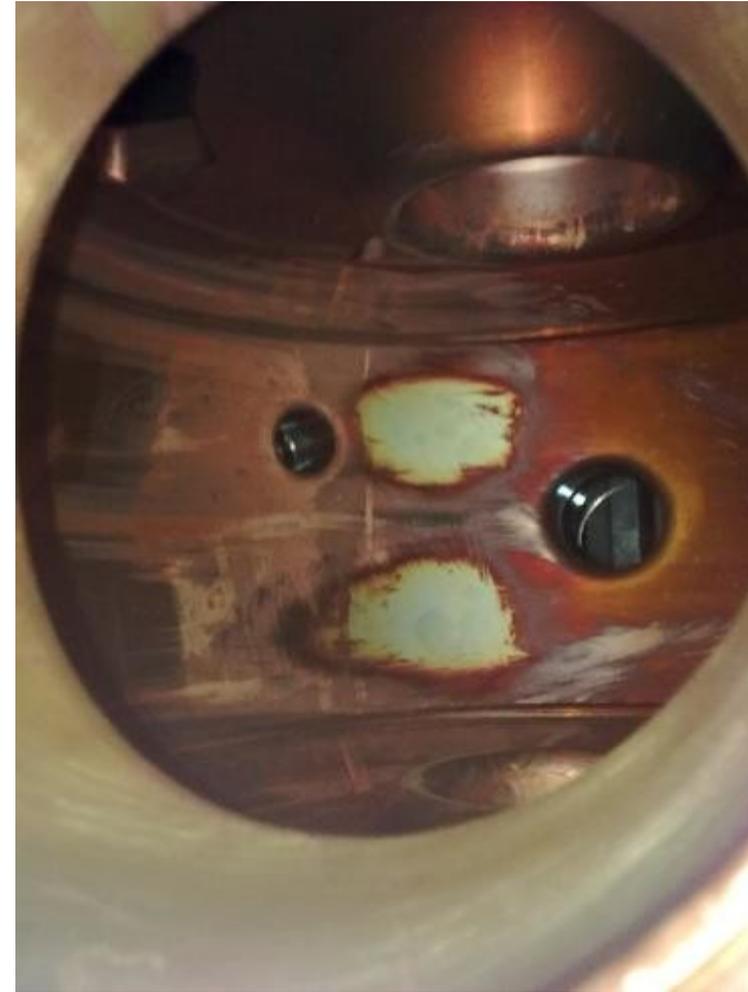
Change of coupler and plungers at SR_Cy3. 2012-04-16.

After many trips we changed the coupler and the plungers. One of them looks strange.

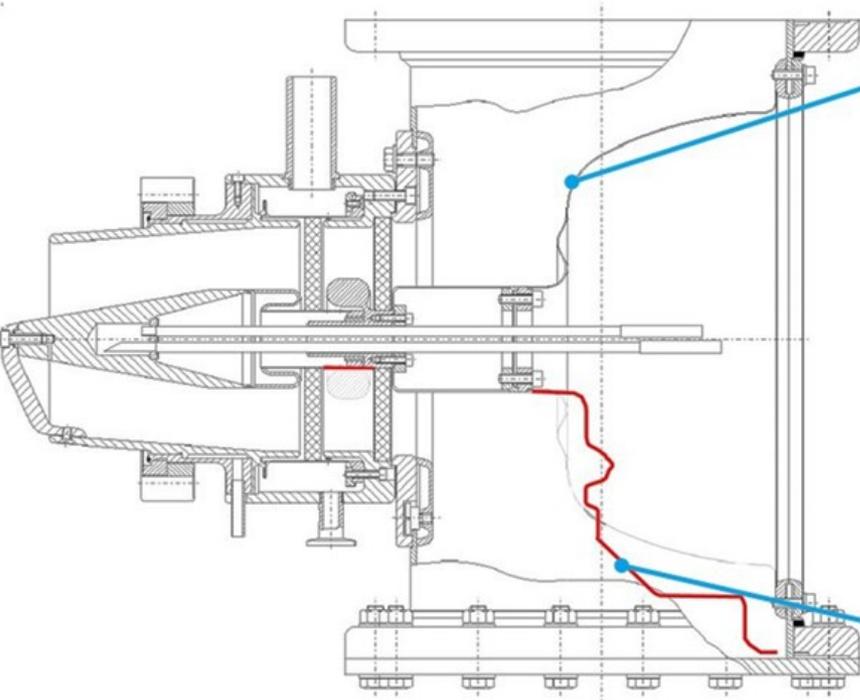
original: round
return loss: -7 dB

Better matching with different doorknob.

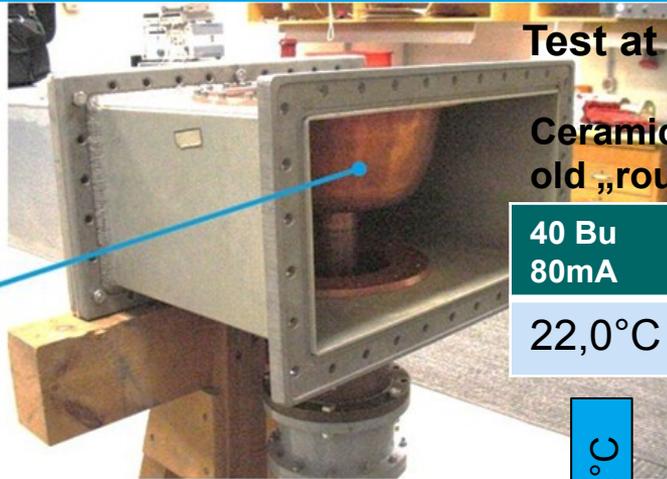
recovered: angled, multi steps:
return loss: -33 dB

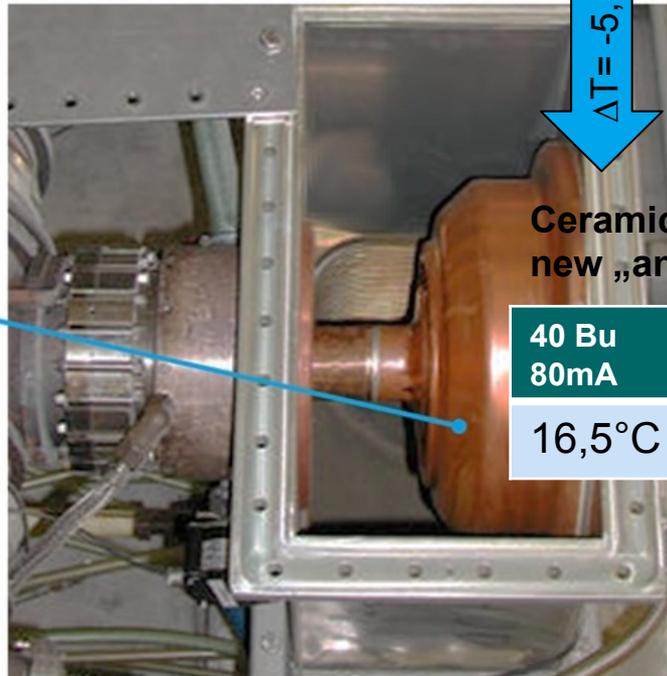
Test at SR_Cy6:

Ceramic window- ΔT with old „round“ doorknob

40 Bu 80mA	60Bu 100mA	240Bu 100mA
22,0°C	21,8°C	17,4°C

$\Delta T = -5,5^\circ\text{C}$

$\Delta T = -3,1^\circ\text{C}$

$\Delta T = -5,1^\circ\text{C}$

Ceramic window- ΔT with new „angled“ doorknob)

40 Bu 80mA	60Bu 100mA	240Bu 100mA
16,5°C	18,7°C	12,3°C

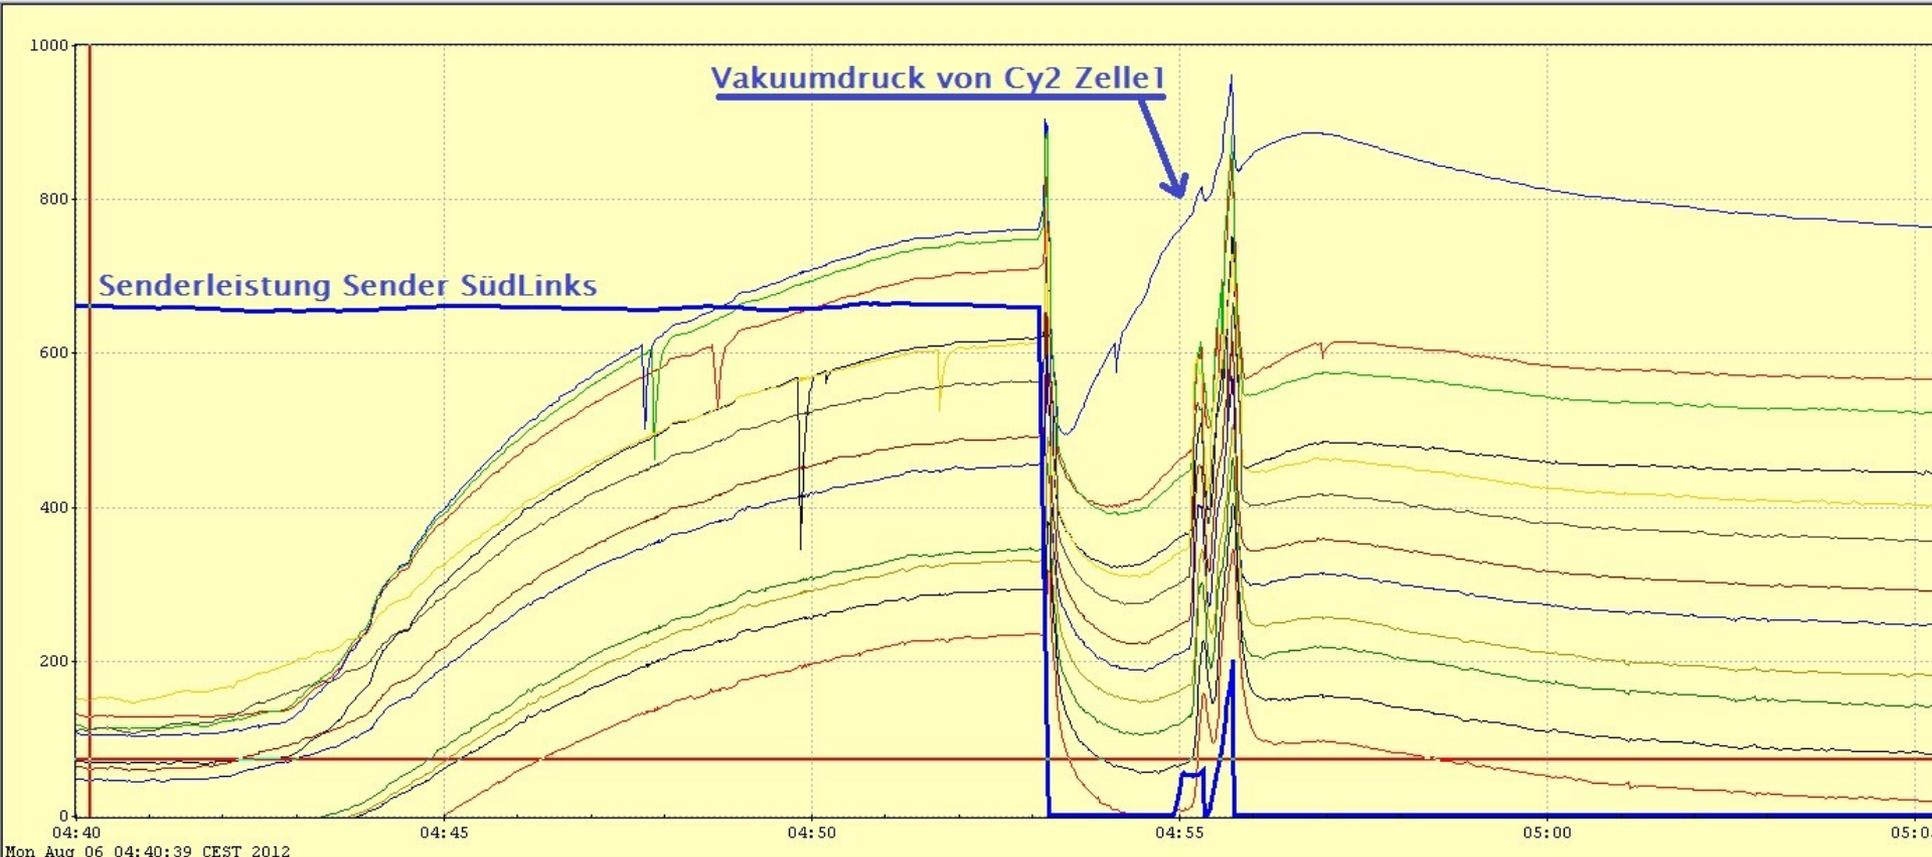
vacuum event.

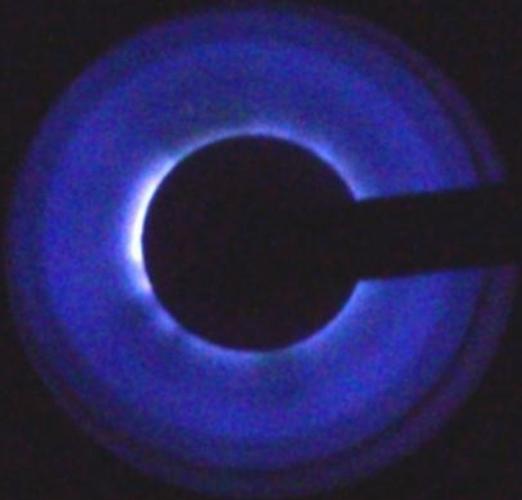
Blue light.

2012-08-06:
at SL_Cy2
starts at ca. 8 kW
but did not expire
up to ca. 35 kW
